March 18, 2002

**RE: EVALUATION OF MASS WASTING, BRANSON PROPERTY,
BURIEN, WASHINGTON**

Burien Parks Department Branson Property Burien, Washington	
SITE SKETCH	
March 2002	21-1-09670-001
SHANNON & WILSON, INC. Geotechnical and Environmental Consultants	FIG. 2

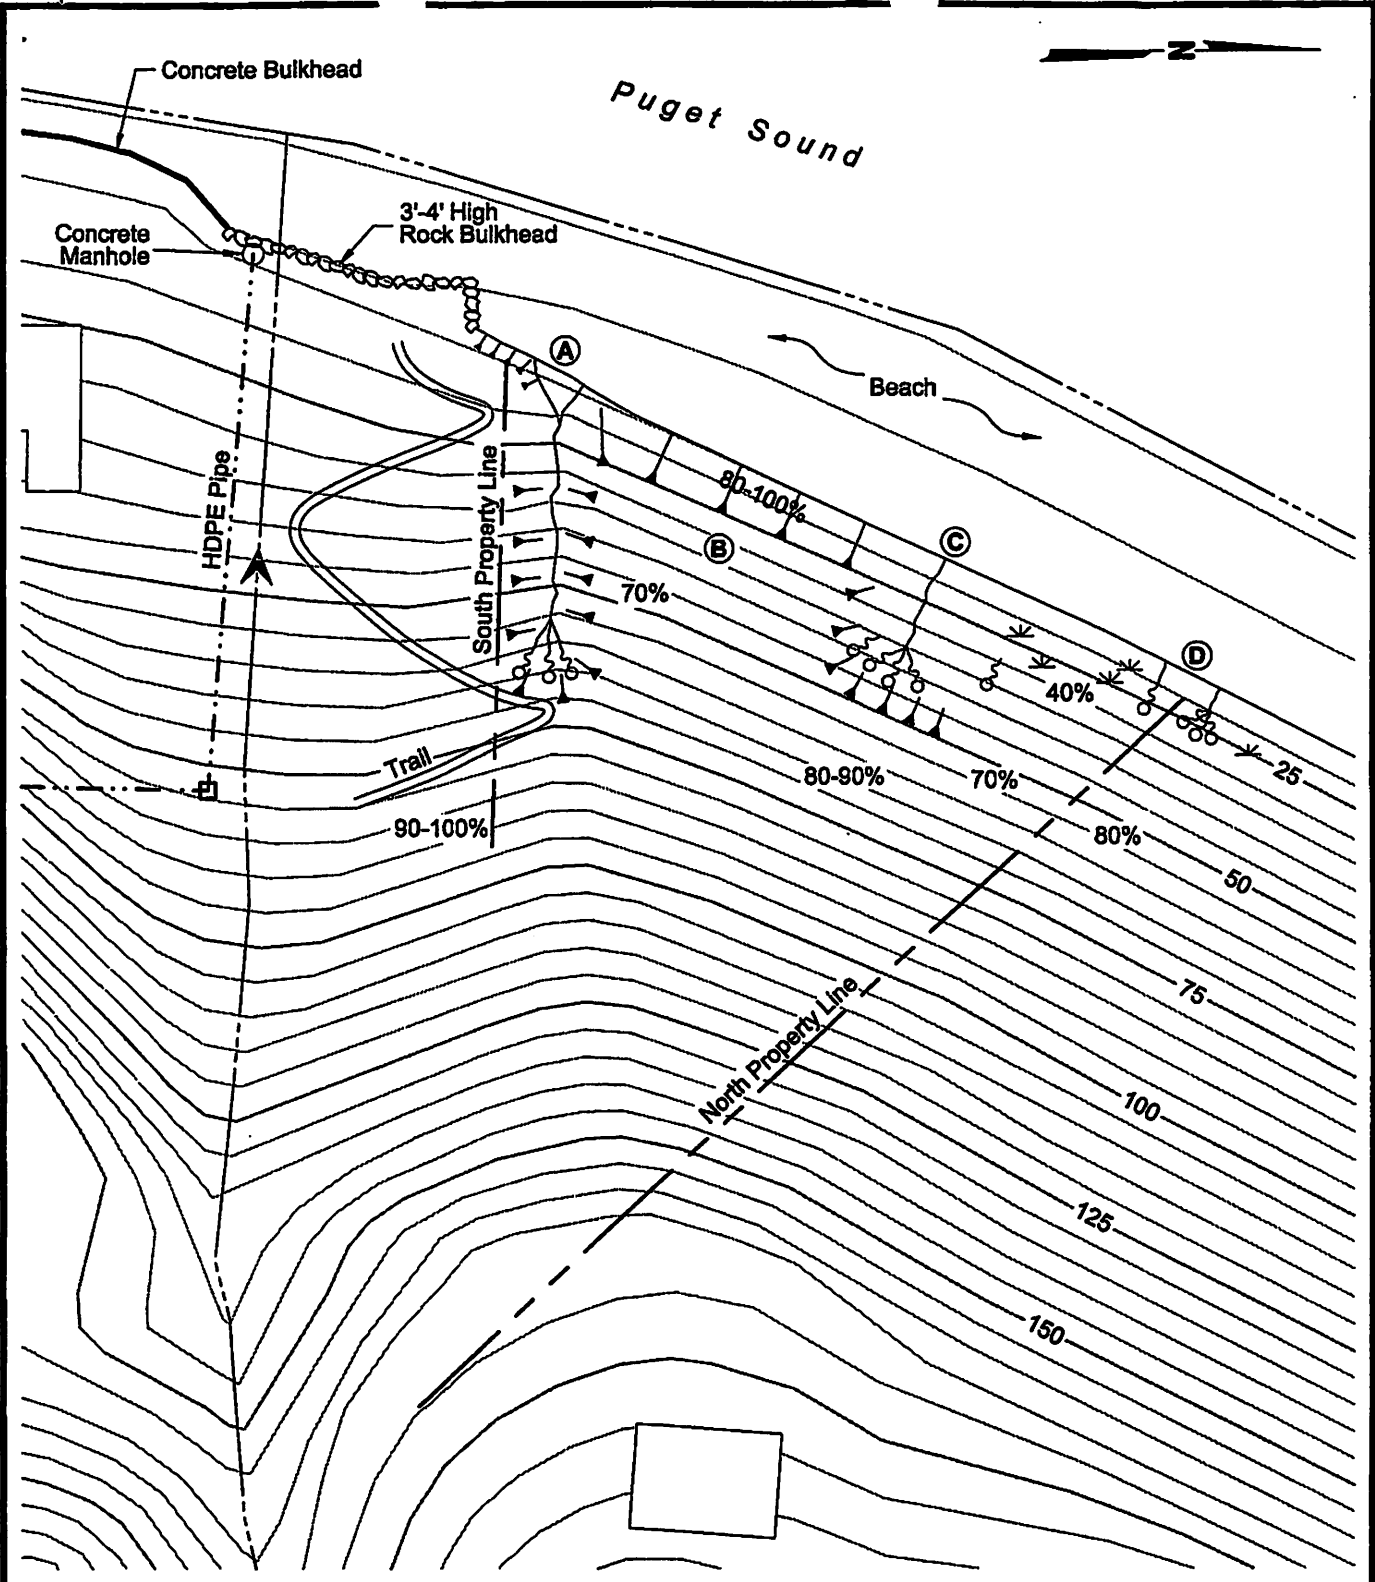
Groundwater was observed at about elevation 65 feet at the head of a small chute near the southern property line. The springs form a small creek that runs down the chute to the shoreline. In the central portion of the site, at about elevation 40 feet, springs emerge from the hillside in an area about 40 feet wide. Their waters coalesce and flow to the shoreline in a small creek. Near the north property line, diffuse water emerges from the gentle slope at about elevation 25 feet. This water flows to the beach in two places, as shown on Figure 2.

Mass movement (slope instability) is apparent in three forms at this site.

- (1) At the south edge of the site, a debris chute is present. Such a chute empties periodically, depositing soil at the toe of the chute. A debris deposit is present at site A, as indicated on Figure 2. The debris deposit is comprised of a fan of very loose, silty, gravelly sand. The toe of the deposit is being eroded by storm waves. There is evidence that such a process has also occurred at the head of the central springs, but no debris deposits remain at the toe of the slope, presently. However, the presence of gravel throughout the length of the small creek indicates that gravel is delivered occasionally to the beach.

- (2) At site B, which appears to be a thick landslide deposit, the toe of the slope is oversteepened and cut by arcuate bowl-shaped slumped areas. These features are indicative of local undercutting by storm wave action and/or slumping due to local seepage pressures. The materials that comprise this very steep bank are clean to slightly silty, gravelly sand.

- (3) At sites C and D, the spring-fed creeks are actively carrying silt, fine sand and fine organics to the beach. In some cases, the fine sediment is temporarily blocked by logs on the beach, but this material is then periodically entrained by storm waves.
